**Richard Oruko Ongong<sup>1)</sup>**  
**Wilkister N. Moturi<sup>1)</sup>**  
**John M. Mironga<sup>1)</sup>**

## **ASSESSMENT OF TANNERY BASED SOLID WASTES MANAGEMENT IN ASILI, NAIROBI KENYA**

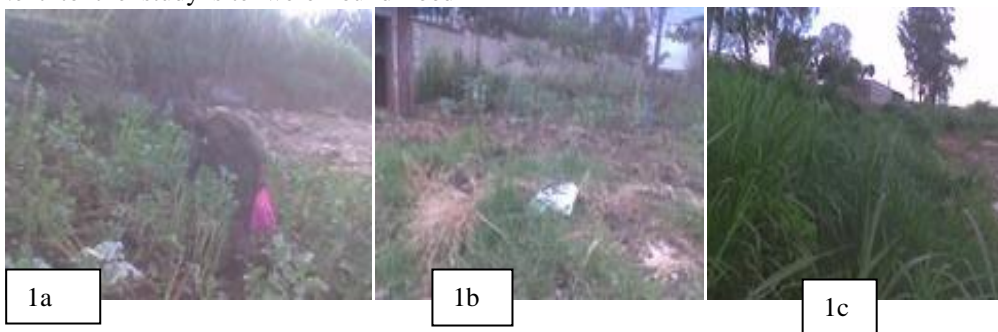
Next to the study site were found food

**Figure 1 - (1a) A worker picking kales (1b) and (1c) cassava and Napier grass grown next to the dump site**

crop like kales, cassava, banana, maize and Napier grass being grown for human and livestock consumption. The high concentration levels of chrome in the soil, as a pollutant may led to its conversion into organic form which can easily biomagnifies/bioaccumulate along the trophic levels, exposing workers, residents of Njiru and their livestock to high risk of carcinogenic effect either directly or indirectly as seen in plate 1. In Italy and Sweden 20-30% cancer risk were found among tannery workers according to Kolomazniket al.,(2008) [10]. Further studies have also shown that even finished leather products—especially those in direct contact with the skin, such as gloves or shoes—contain high levels of a toxic chemical - hexavalent chromium, considered to be a strong allergen that can lead to skin reactions like eczema [9]. Workers in Asili may need regular medical checkups to confirm whether their health is not under threat or compromised by the exposure.

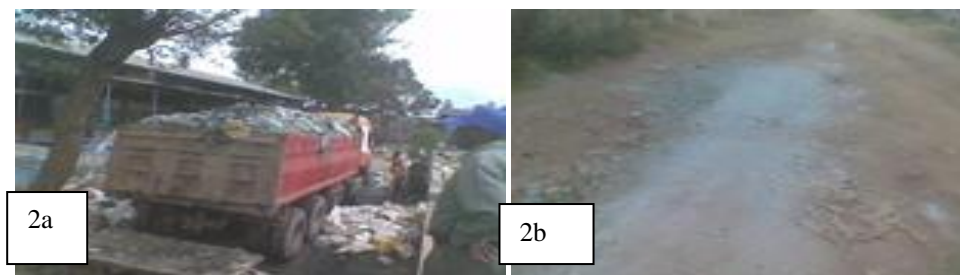
Presence of total chrome in the control soil outside Asili may be suggested to have originated from occasional droppings along the way from open overloaded transporting vehicles as seen in plate 2. Since chrome last longer in the environment it was possible to detect its presence even after a long period as

**Figure 2 – (2a) a vehicle overloaded with wastes.(2b) chrome droppings observed along the road from Aziz tanneries limited.**

Kolomazniketal. (2008) [10] states that “Chromium substances persist in the environment beyond 20 years”. Andrew et al., (2010) suggests that contaminated soils from such pollutants need remediation, excavation and removal as cost-effective measures to break the pathway between the contaminant and the local population

and then construction of a waste treatment facility and secure landfill to contain them. Failure to put those measures in place is likely to expose the public to the potential entrance of chrome through skin and other
