ANALYSIS AND IDENTIFICATION OF NONCONFORMING PRODUCTS BY 5W2H METHOD

3. CASE STUDY – PROCEDURE FOR THE IDENTIFICATION OF NONCONFORMING PRODUCT USING THE 5W2H METHOD

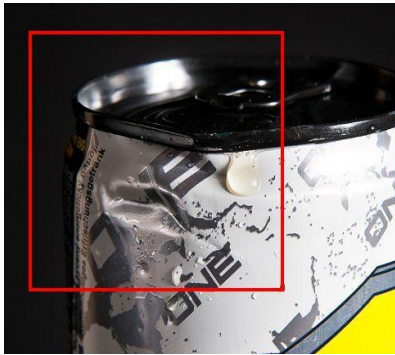
- unfitting cardboard trays causing movement of cans = damage to the protective coating, mechanical damage (Fig. 1).
- thin packaging film – also poor stability,
- uneven distribution on the pallet - poorly distributed weight, deformation of cans.

Figure 1 - Mechanically damaged can

The cans that were mechanically damaged during transport are rejected at the entry inspection when receiving the shipment. If the nonconformities were caused by insufficient sealing of the cap, it would be possible to identify the cause by vertical strips of dried beverage residues, starting below the edge of the rim. After a thorough analysis, both possibilities were rejected. However, the third type of leak was identified after inspecting a large number of randomly selected cans. To clarify the causes, it should be added that the leak of the beverage through the body of the can may be caused only by two reasons, namely:

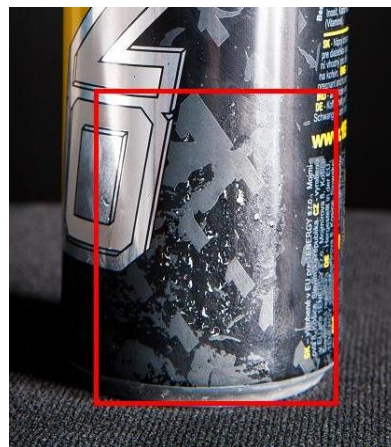
Primary corrosion occurs when the inner surface of the aluminium can is not sufficiently protected by the protective coating applied during the manufacturing process, as described in the previous chapter. The beverage, which contains citric acid, reacts with the thin material of the exposed can and consequently causes a leak. The secondary corrosion occurs when the can is not well protected from the outside – the thickness of the outer coating is insufficient. Corrosion then arises from external moisture. It passes through the thin layer of the can from the outside, resulting in microscopic cracks in the structure of the can body and it causes leakage of the beverage. The secondary corrosion was observed on a large number of randomly selected samples (Fig. 2).

Figure 2 - Secondary corrosion

This type of corrosion was observed on all samples in almost identical areas, indicating a systemic error. Moisture which caused the secondary corrosion came from some randomly mechanically damaged cans. These had been removed during the initial inspection. The period lasting three weeks before the problem was noticed indicates the fast rate of the reaction. Had the whole batch not been immediately resorted, the chain reaction could have deteriorated the entire consignment.

The technical condition of the supplier's equipment directly affects the quality of the product. The discovery of bearings that are no longer able to fulfil their function was unacceptable. The first corrective action was to exchange all shaft bearings, which exceeded their lifetime. Another corrective action that prevents shipment of nonconforming product is a more thorough final inspection. Each batch of cans produced on a given day has to undergo rigorous metrological processes.
